**FOCUSED SITE INSPECTION PRIORITIZATION
SITE EVALUATION REPORT**

**LIDLAW AVENUE LANDFILL
(ALSO KNOWN AS LIDLAW CITY DUMP)
935 LIDLAW AVENUE
CINCINNATI, HAMILTON COUNTY, OHIO**

EPA ID NO. OHD 000 810 176

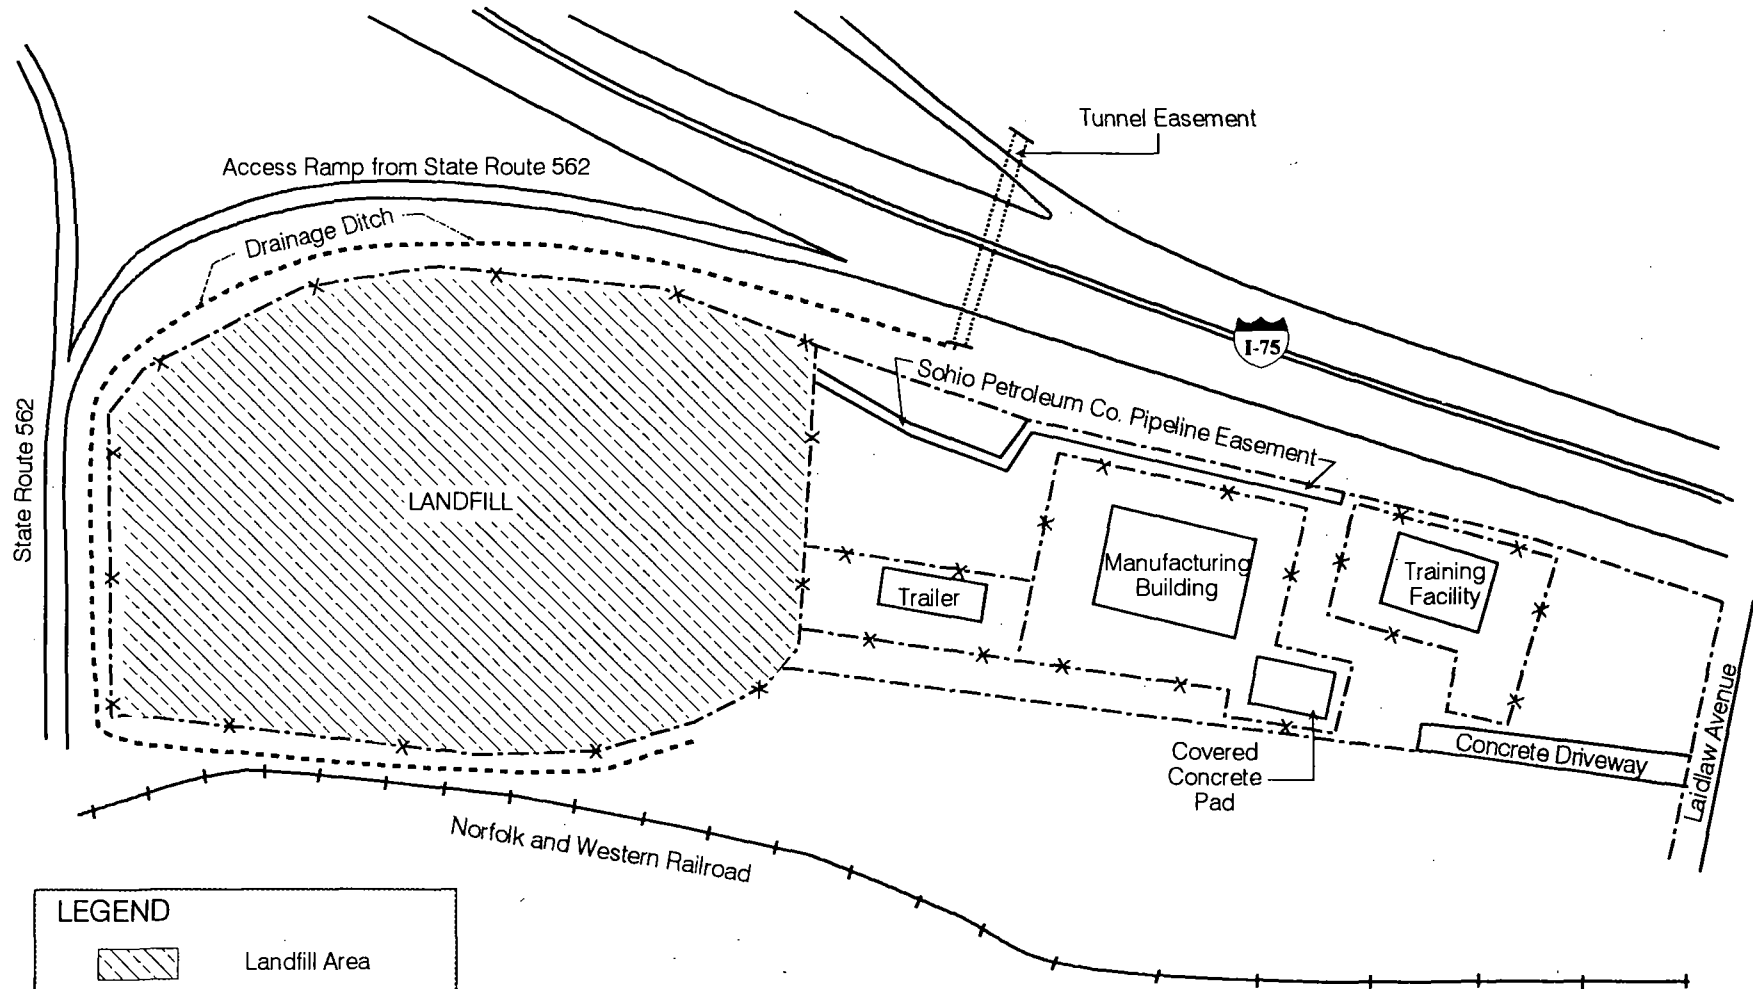
In addition to the landfill, four structures are located on site. A P&G training facility lies on the northernmost corner of the site property. A nonoperational P&G perfume manufacturing building is located about 150 feet south of the training facility. A covered, cement-diked, concrete storage pad lies immediately northeast of the manufacturing building. An abandoned construction trailer lies about 50 feet south of the manufacturing building. Figure 2 shows the site layout.
